Debris/Ice/TPS Assessment And Photographic Analysis For Shuttle Mission STS-39

Gregory N. Katnik
NASA/Kennedy Space Center

June 1991

DEBRIS/ICE/TPS ASSESSMENT
AND
PHOTOGRAPHIC ANALYSIS
OF
SHUTTLE MISSION STS-39

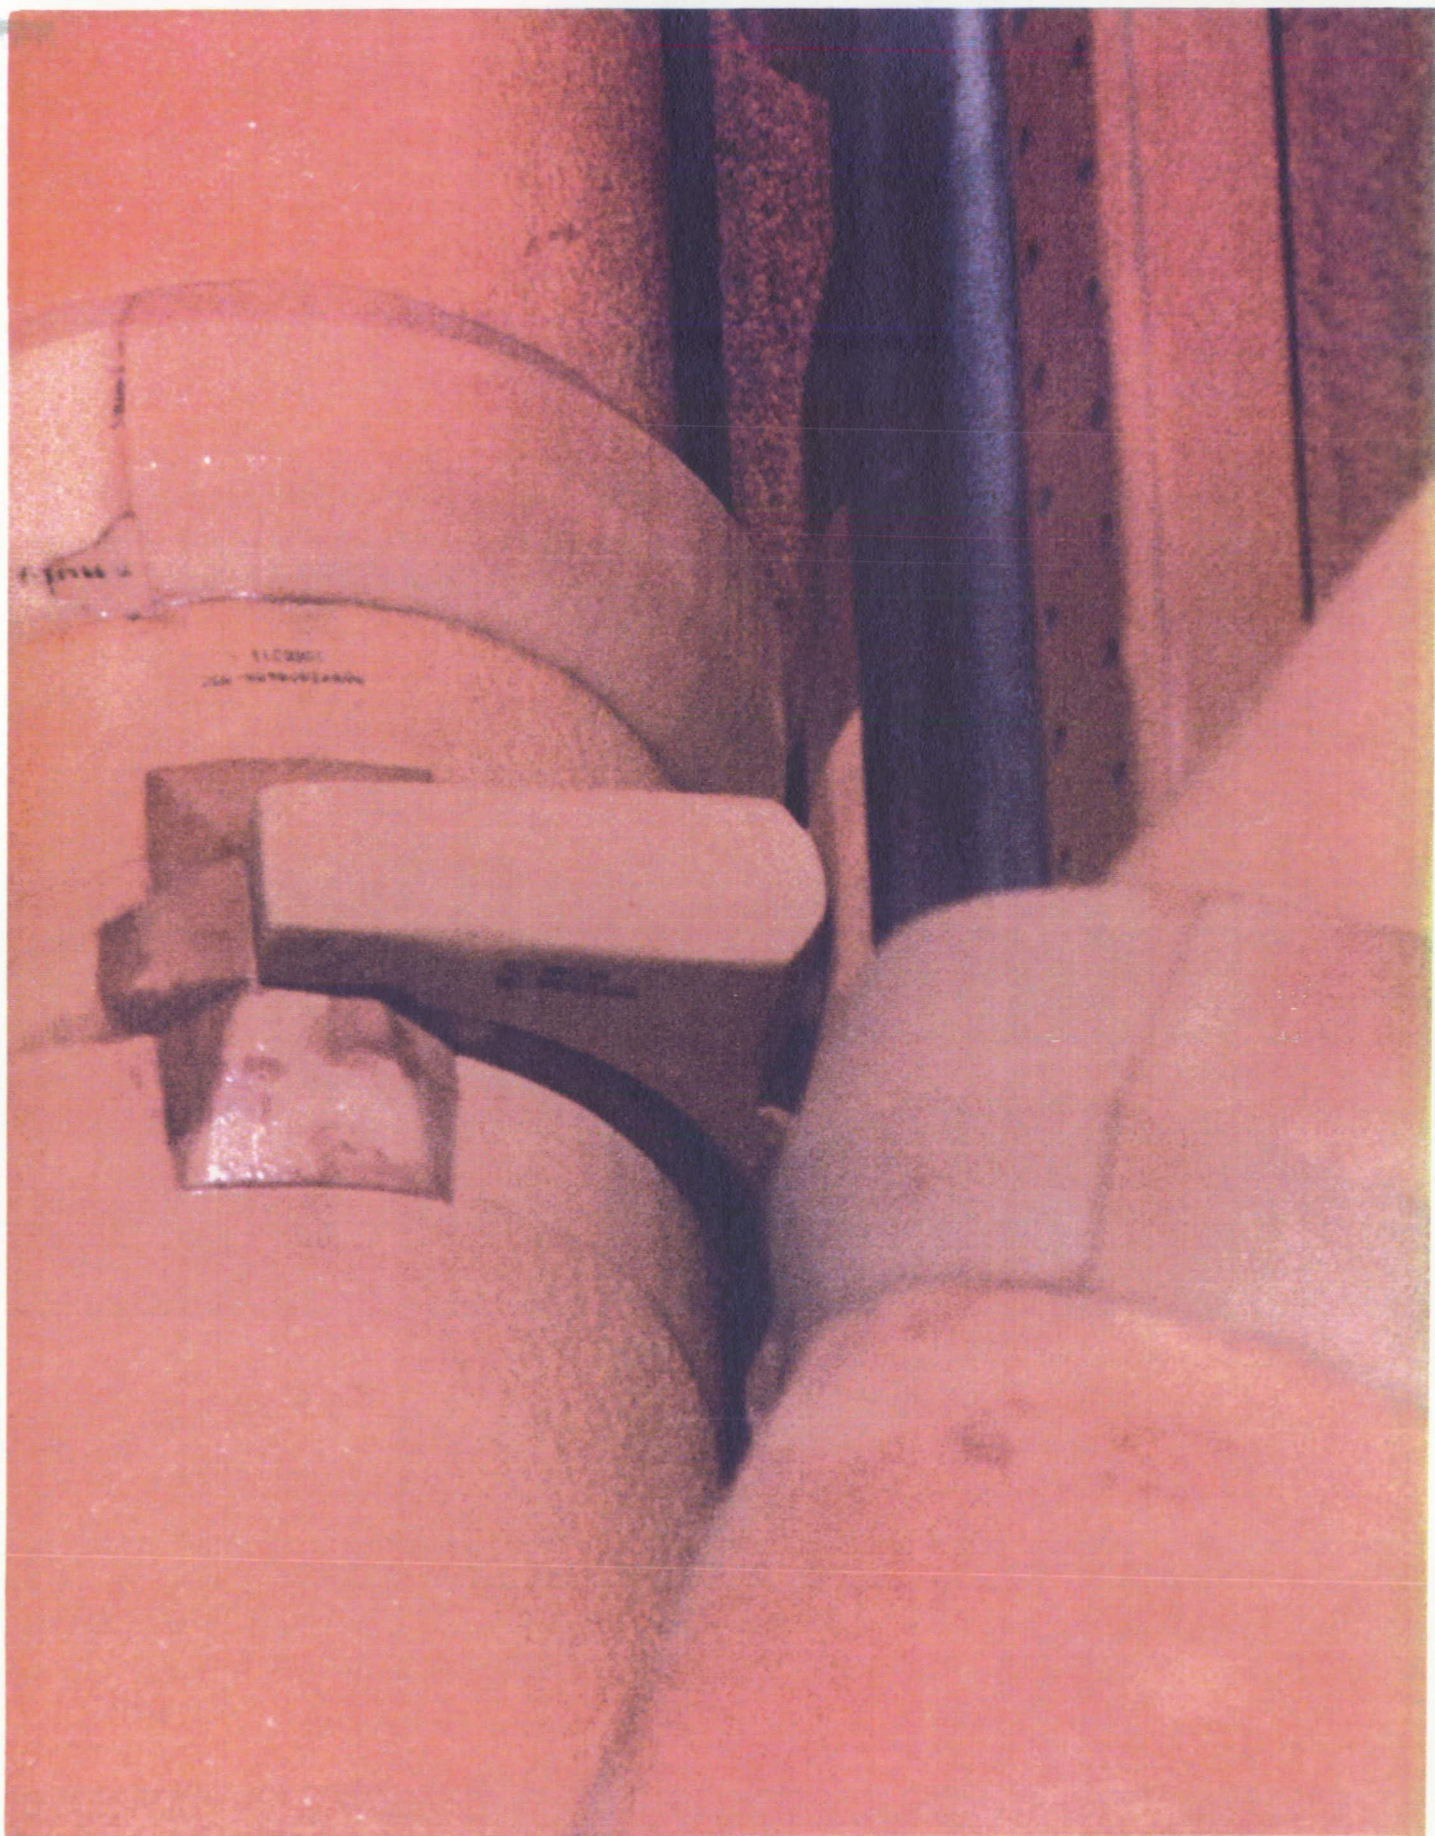
Typical ice/frost accumulation in L02 feedline support bracket

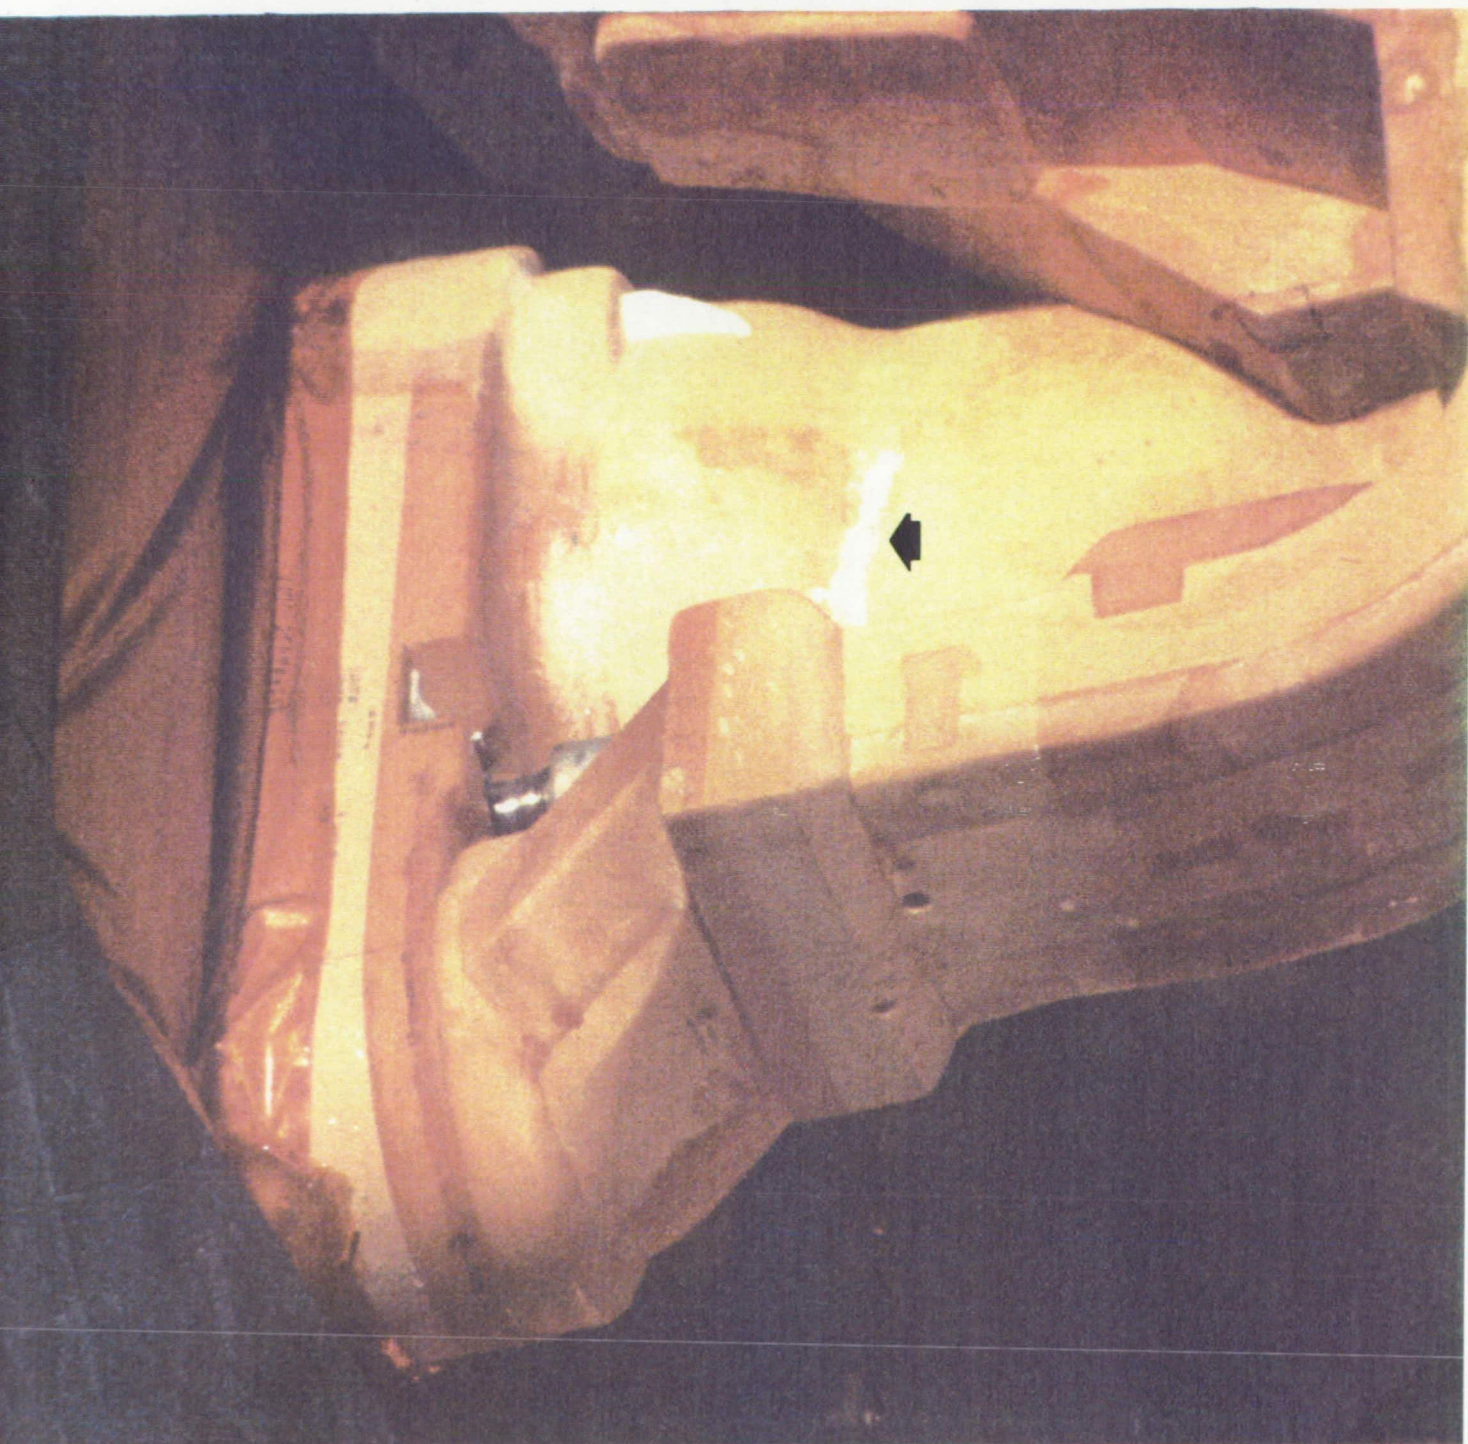
Overall view of L02 ET/ORB umbilical. Ice/frost finger on forward outboard pyrotechnic canister purge vent was typical. No TPS anomalies were visible. White line at L02 feedline-to-umbilical interface was spackling material, not ice or frost.

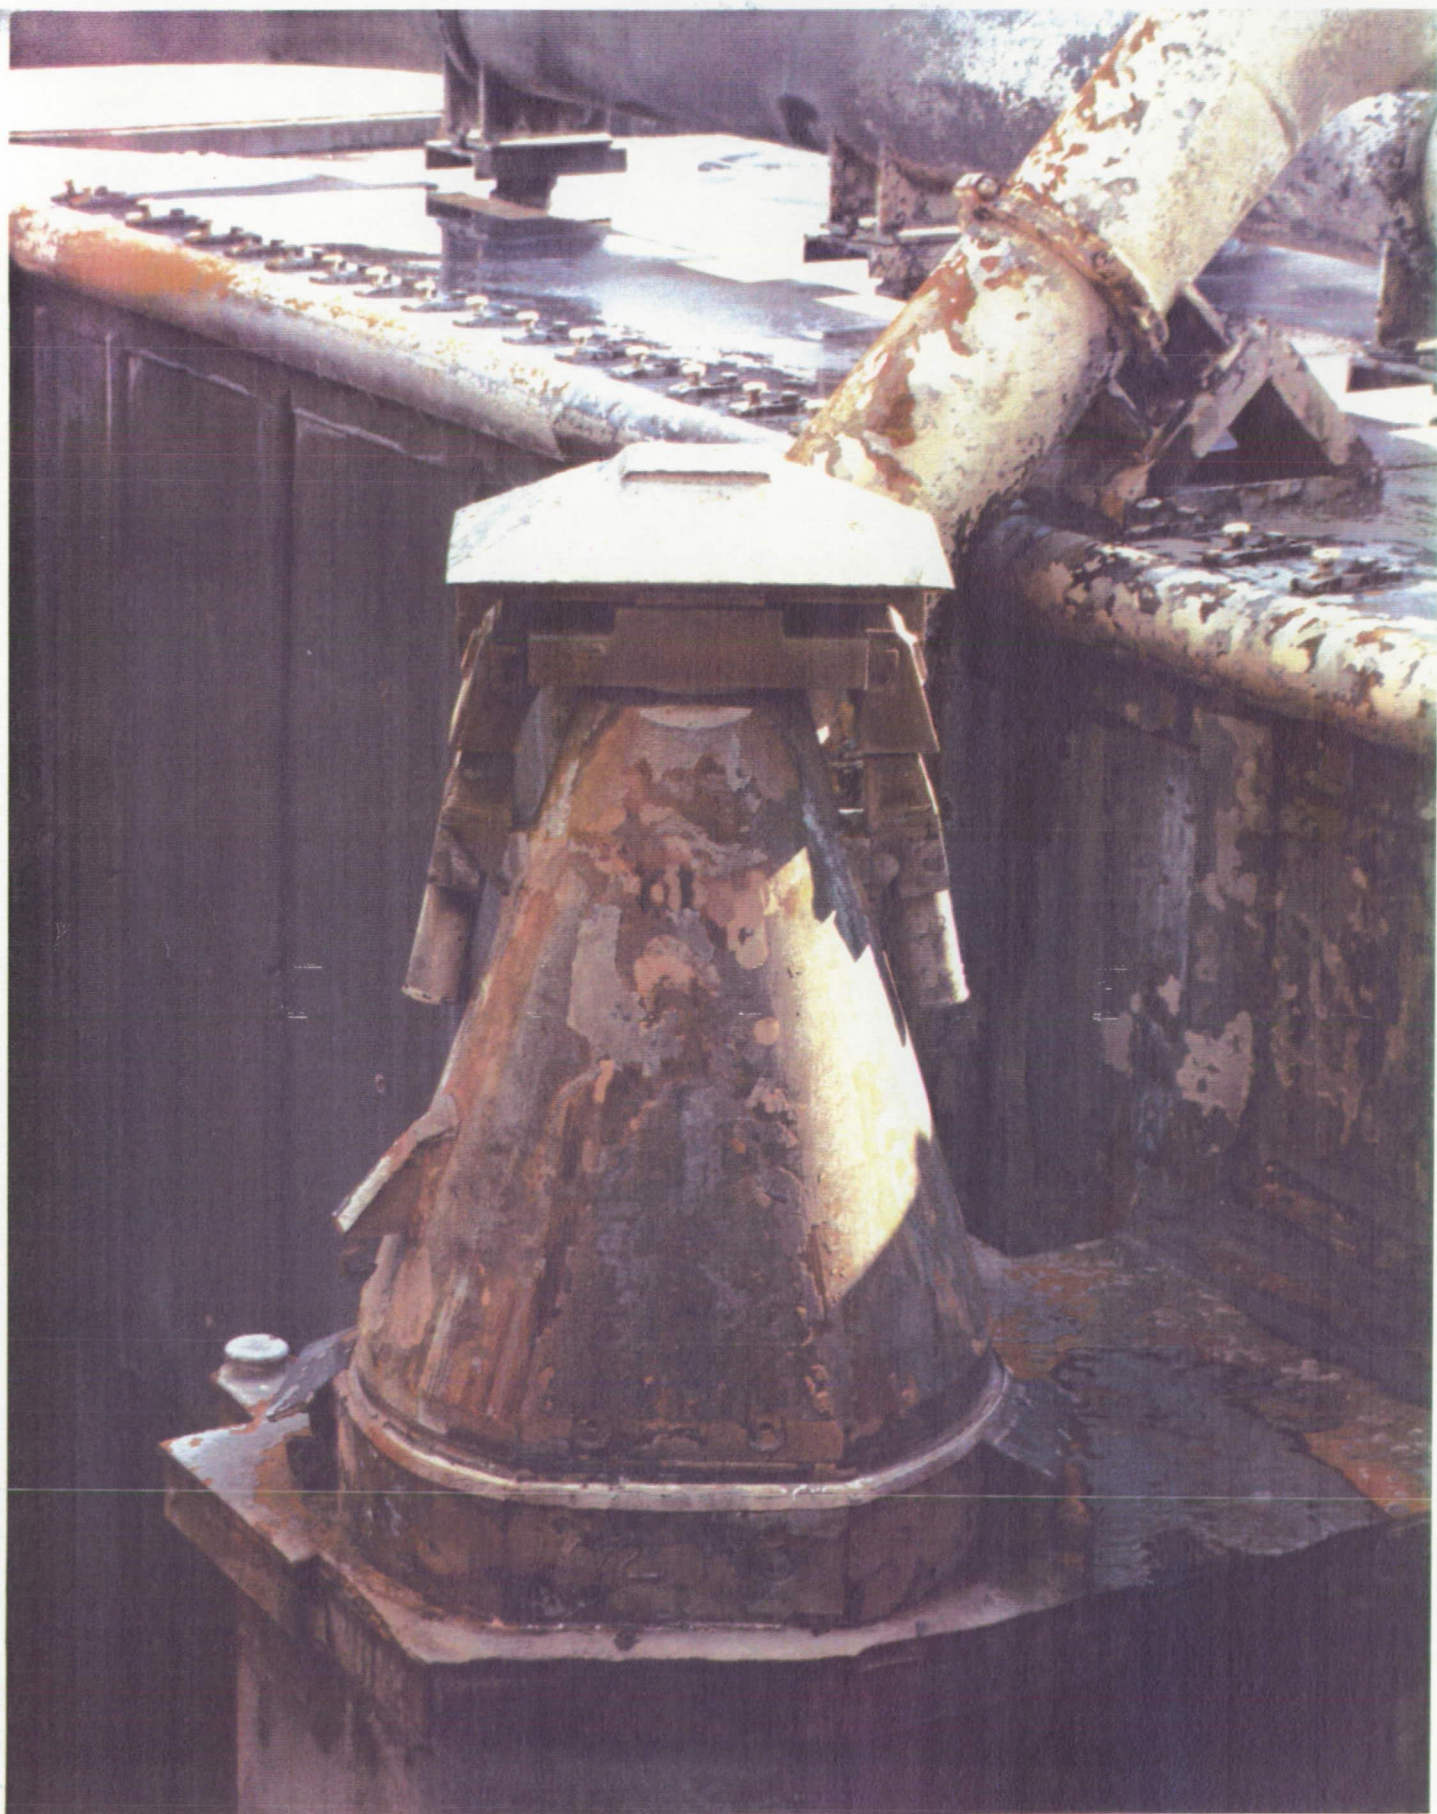
All doghouse blast covers on the north holddown posts had closed properly. Plume erosion appeared to be less than usual.

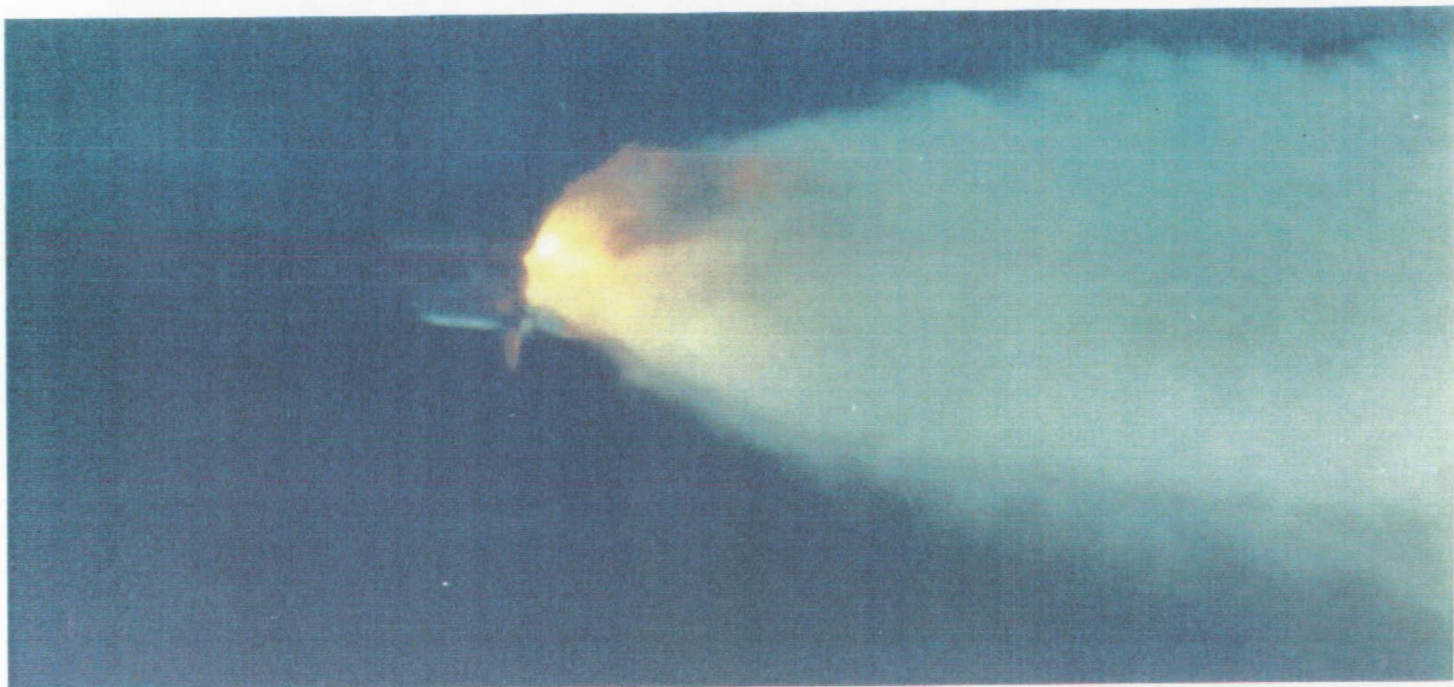
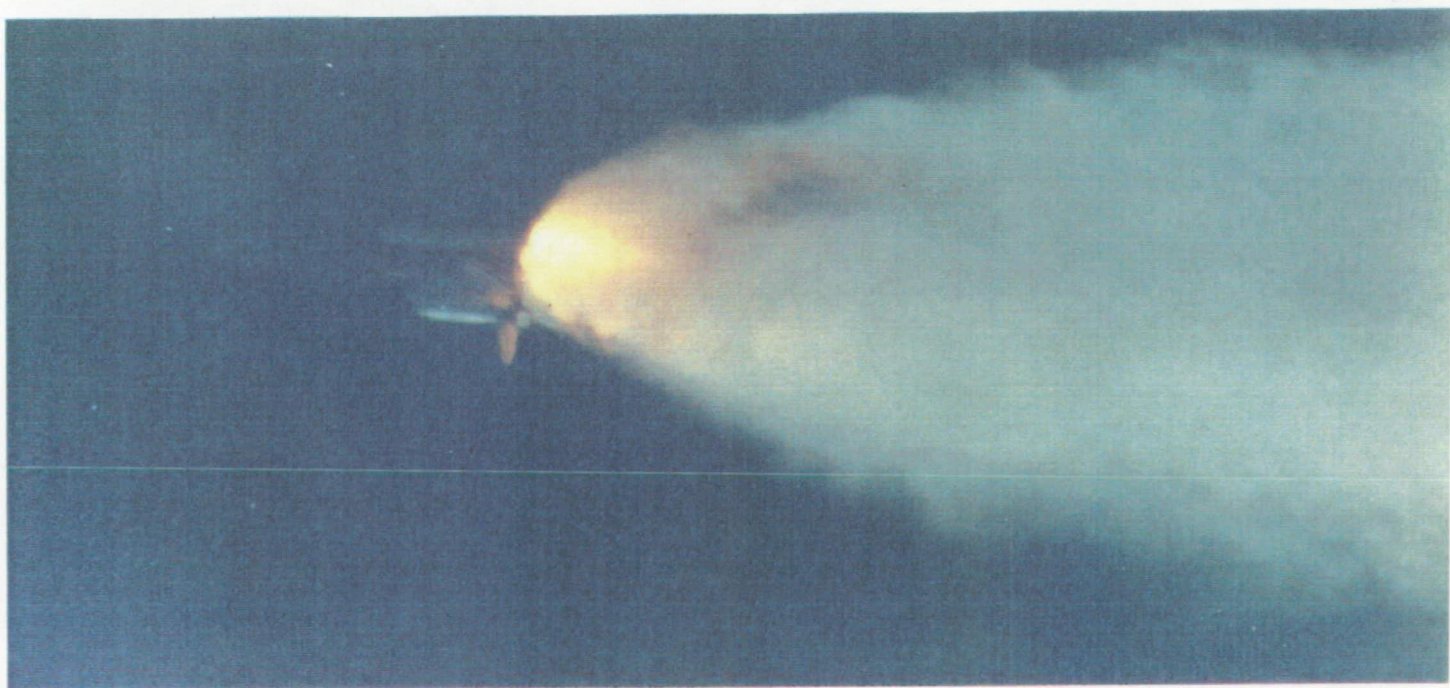
Brightening (more visible flame), along with puffs of darker smoke, occurred in the SRB plume at 111 seconds MET

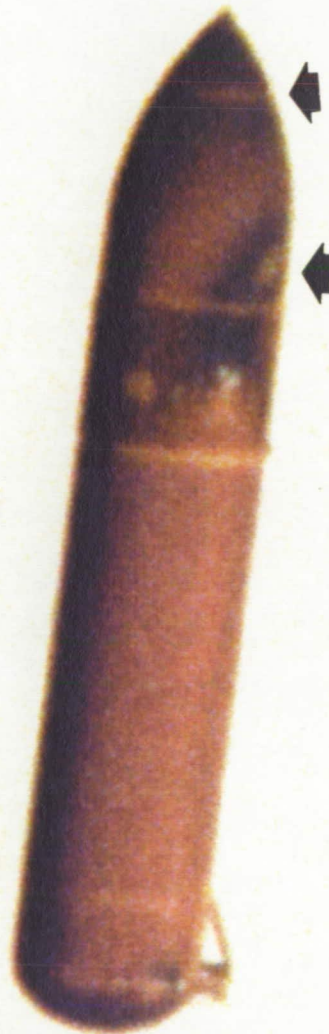
On-orbit view of the External Tank shortly after separation from the Orbiter revealed no major anomalies. BSM burn scar on the LO2 tank is typical. Bright line on the LO2 tank ogive is the SOFI spray interrupt/sanded area - a feature on the tank prior to launch.

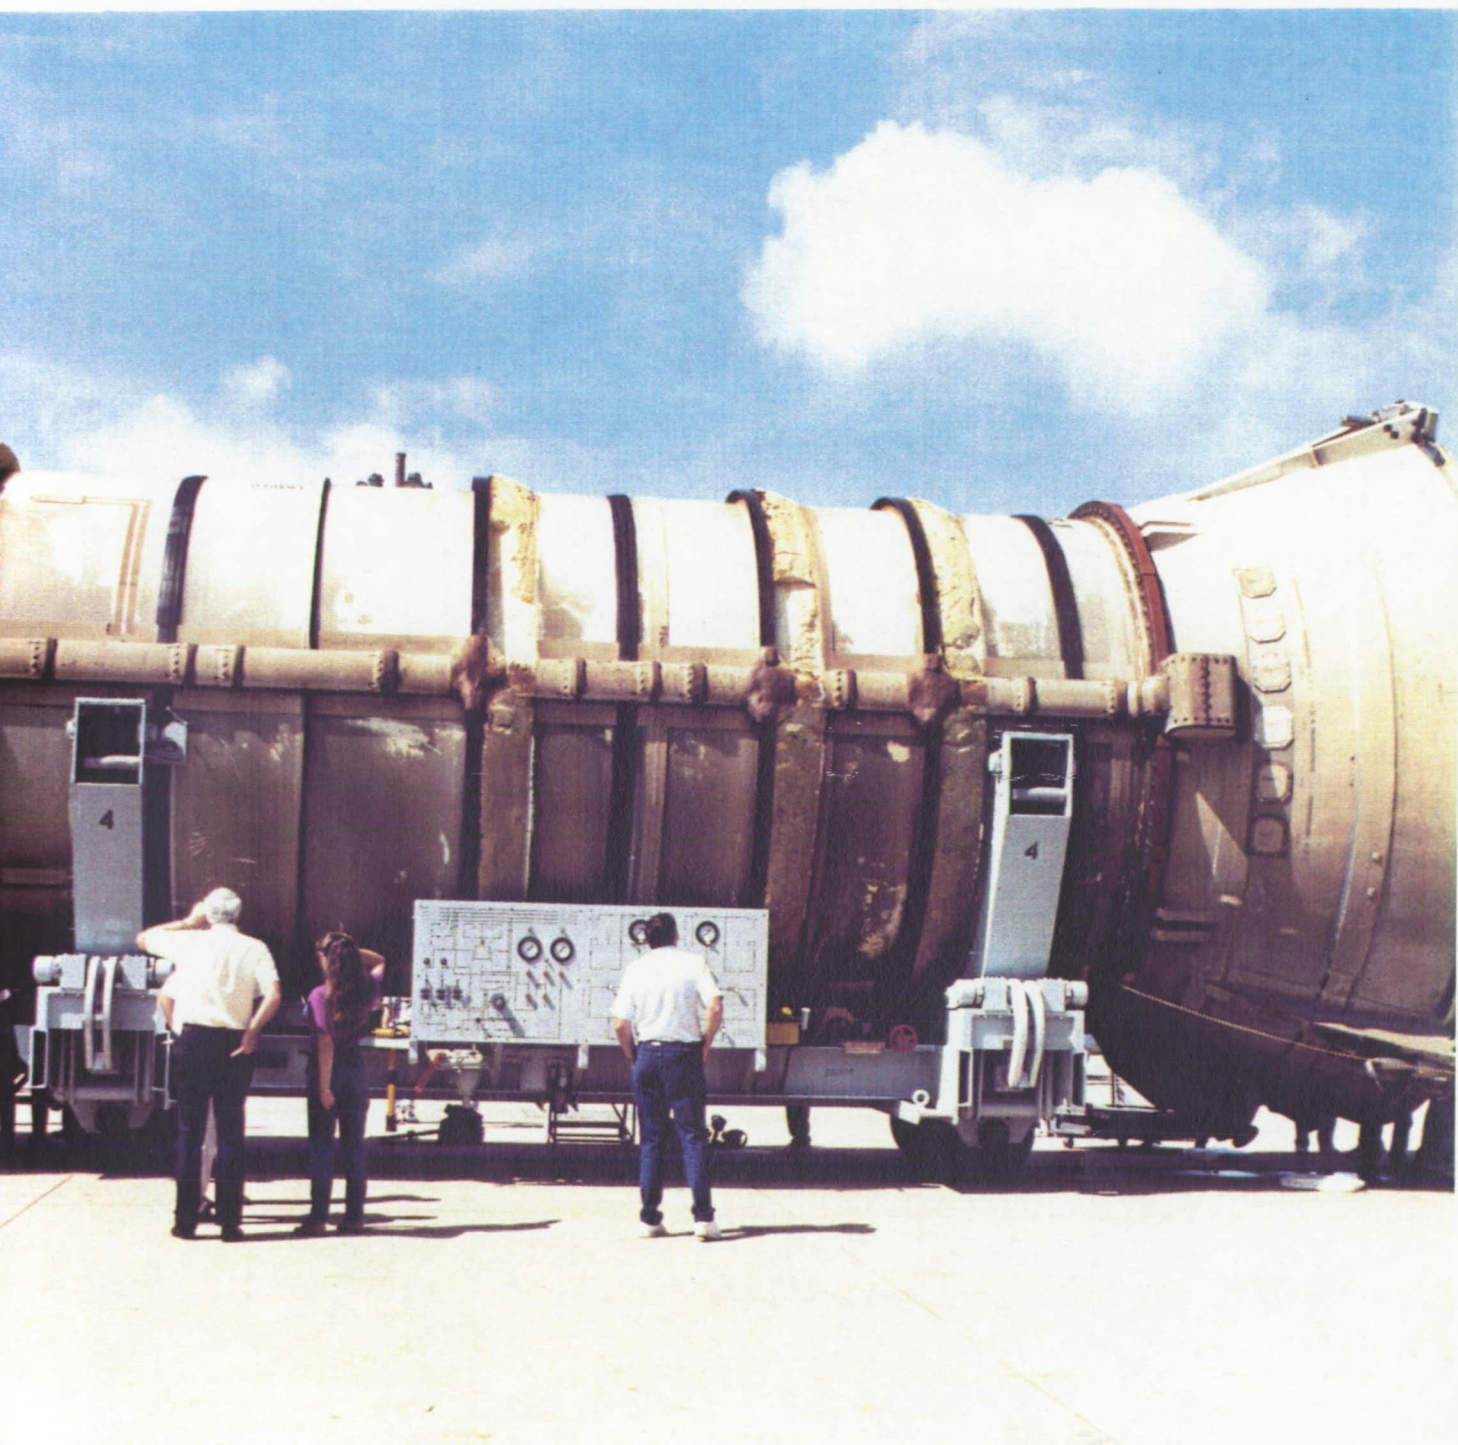
Post flight condition of the RH aft booster

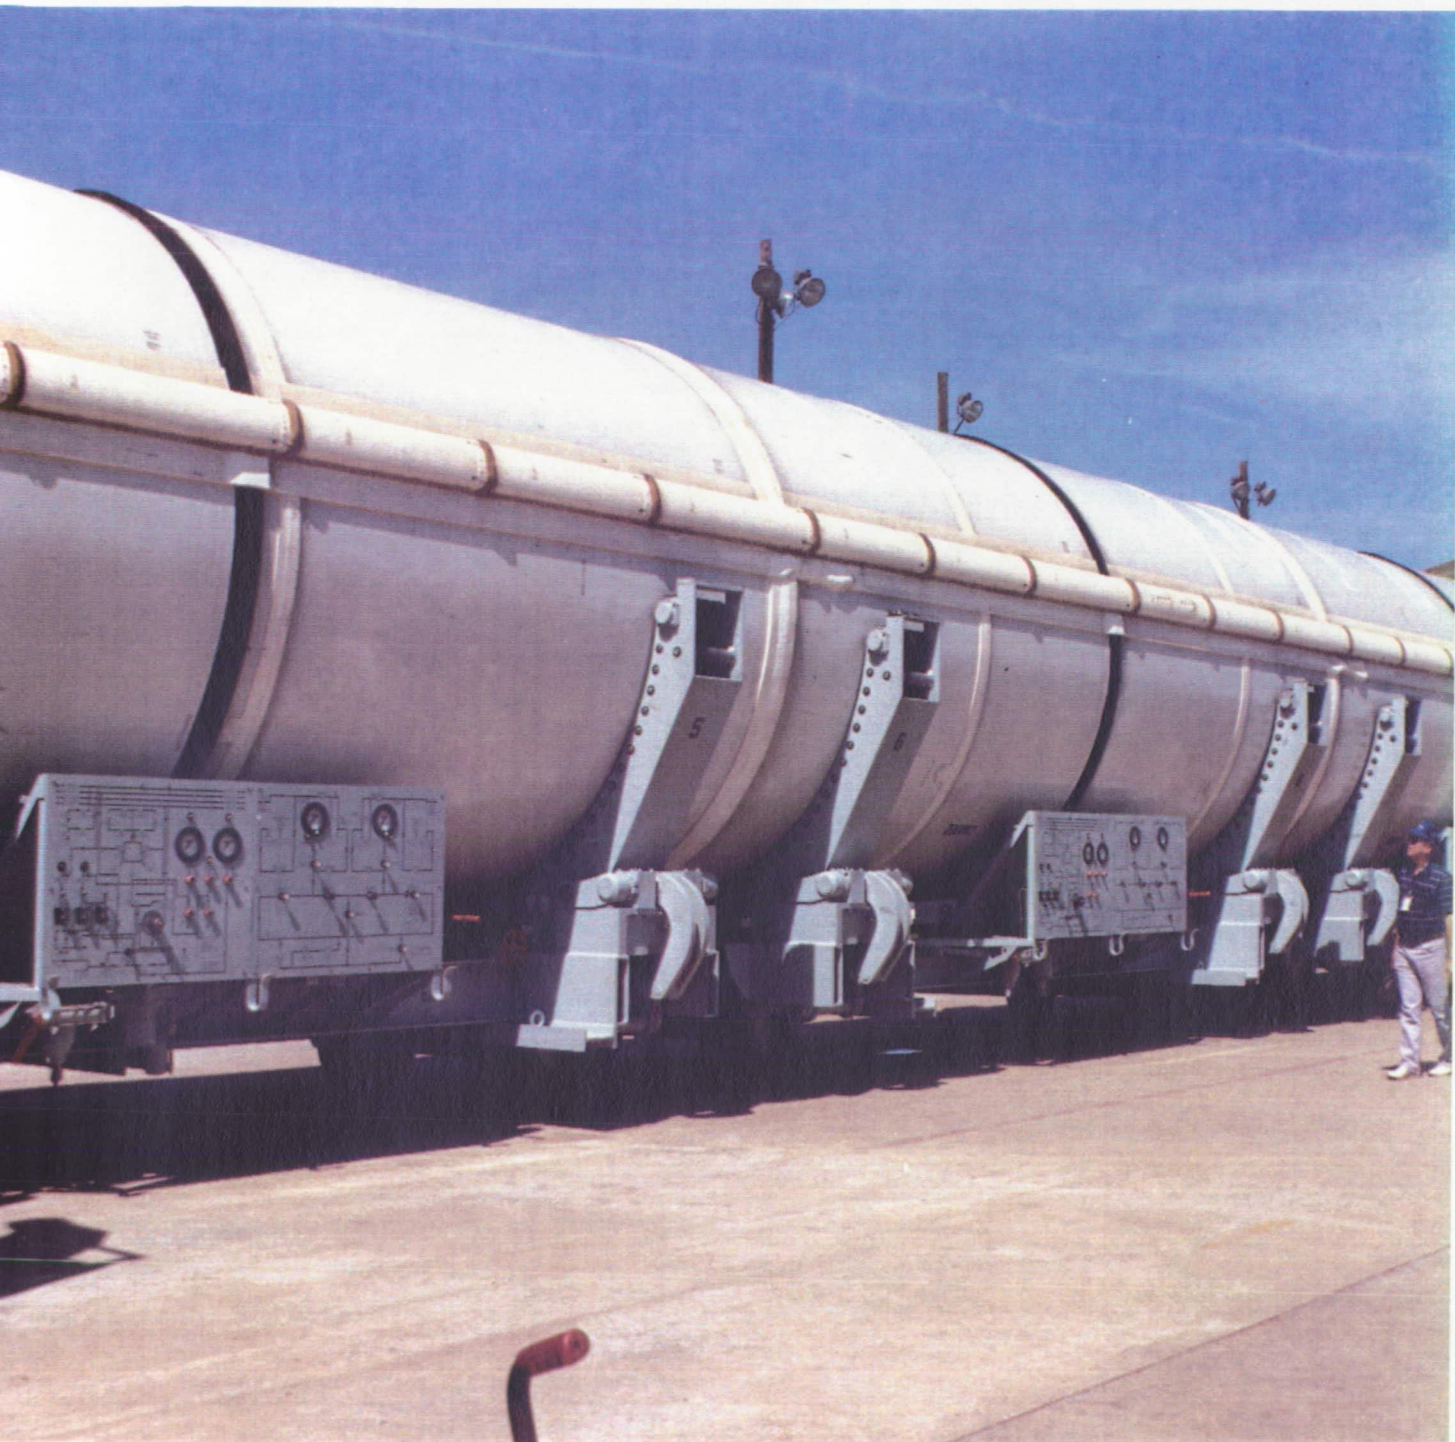
Post flight condition of LH SRM segment cases. The field joint protection system closeouts were generally in good condition.

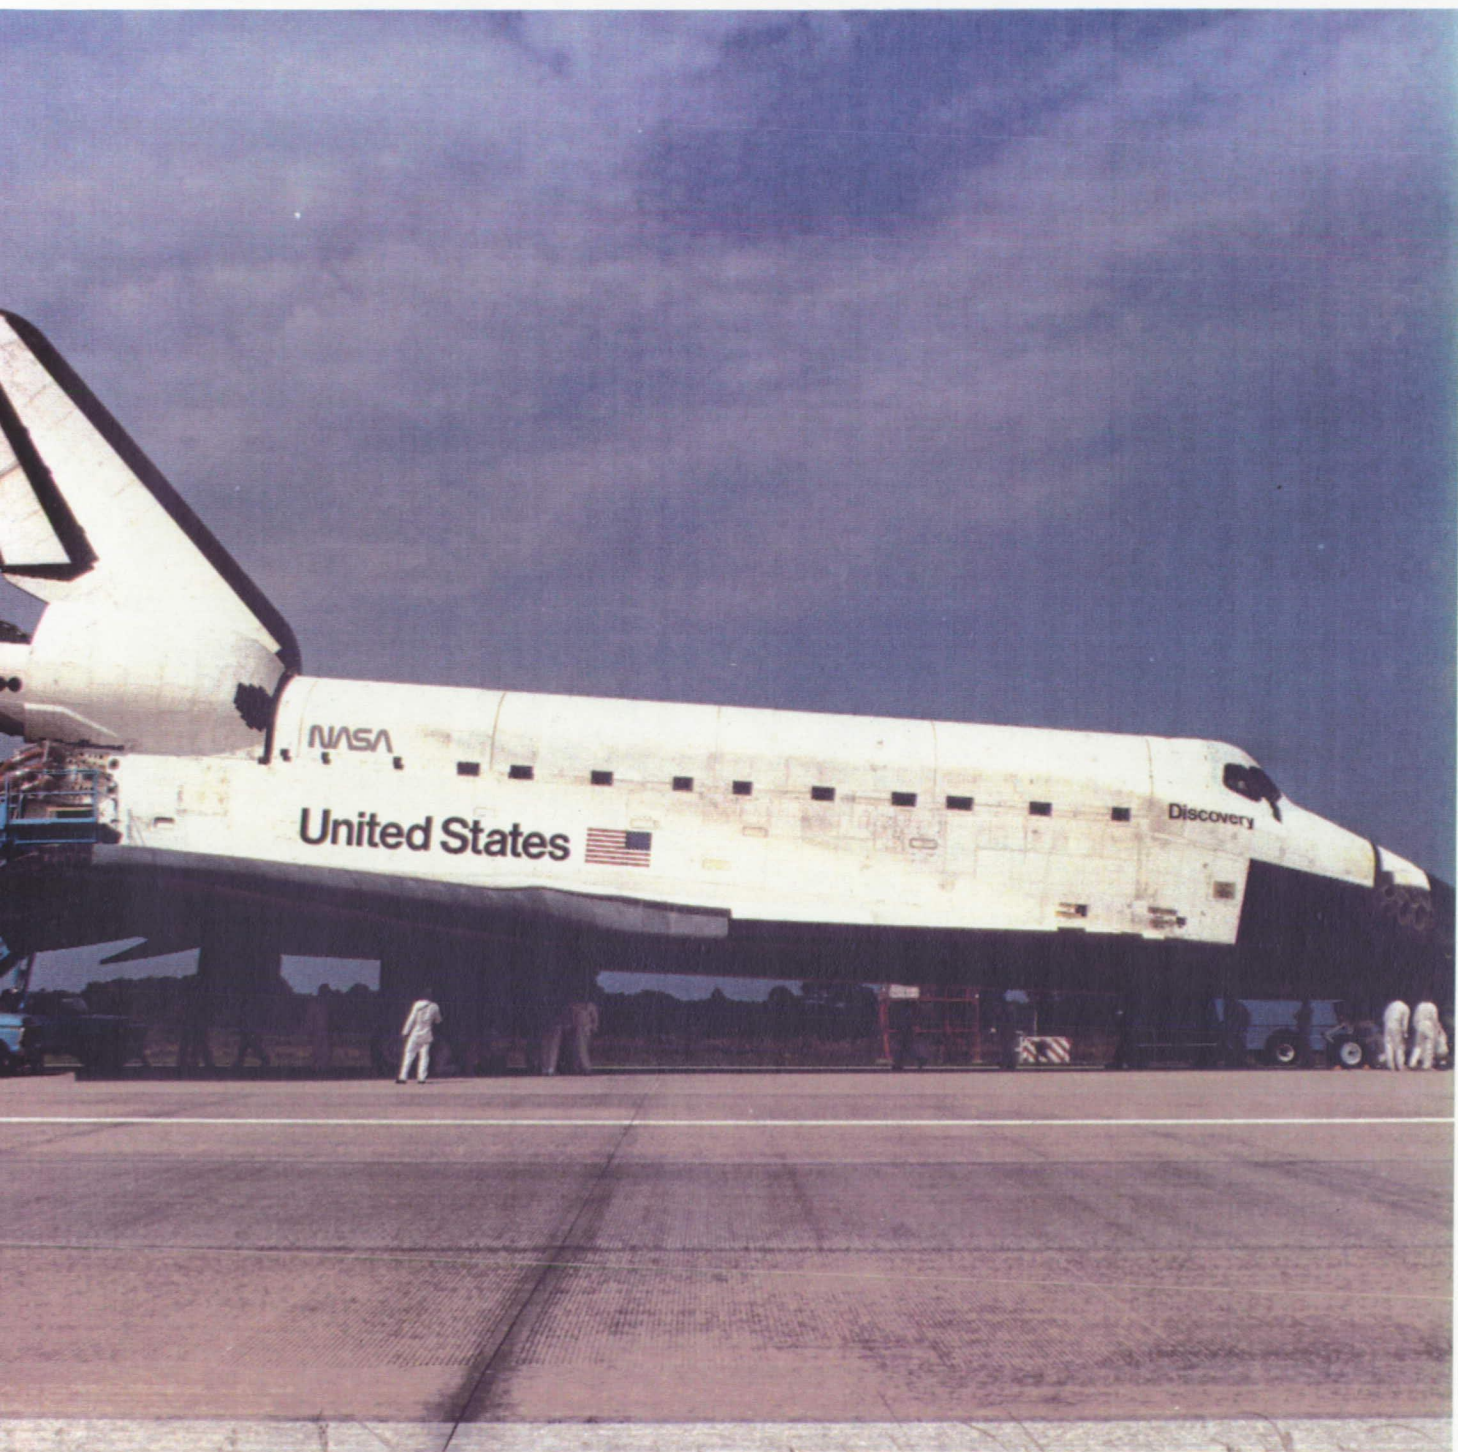
Overall view of OV-103 right side

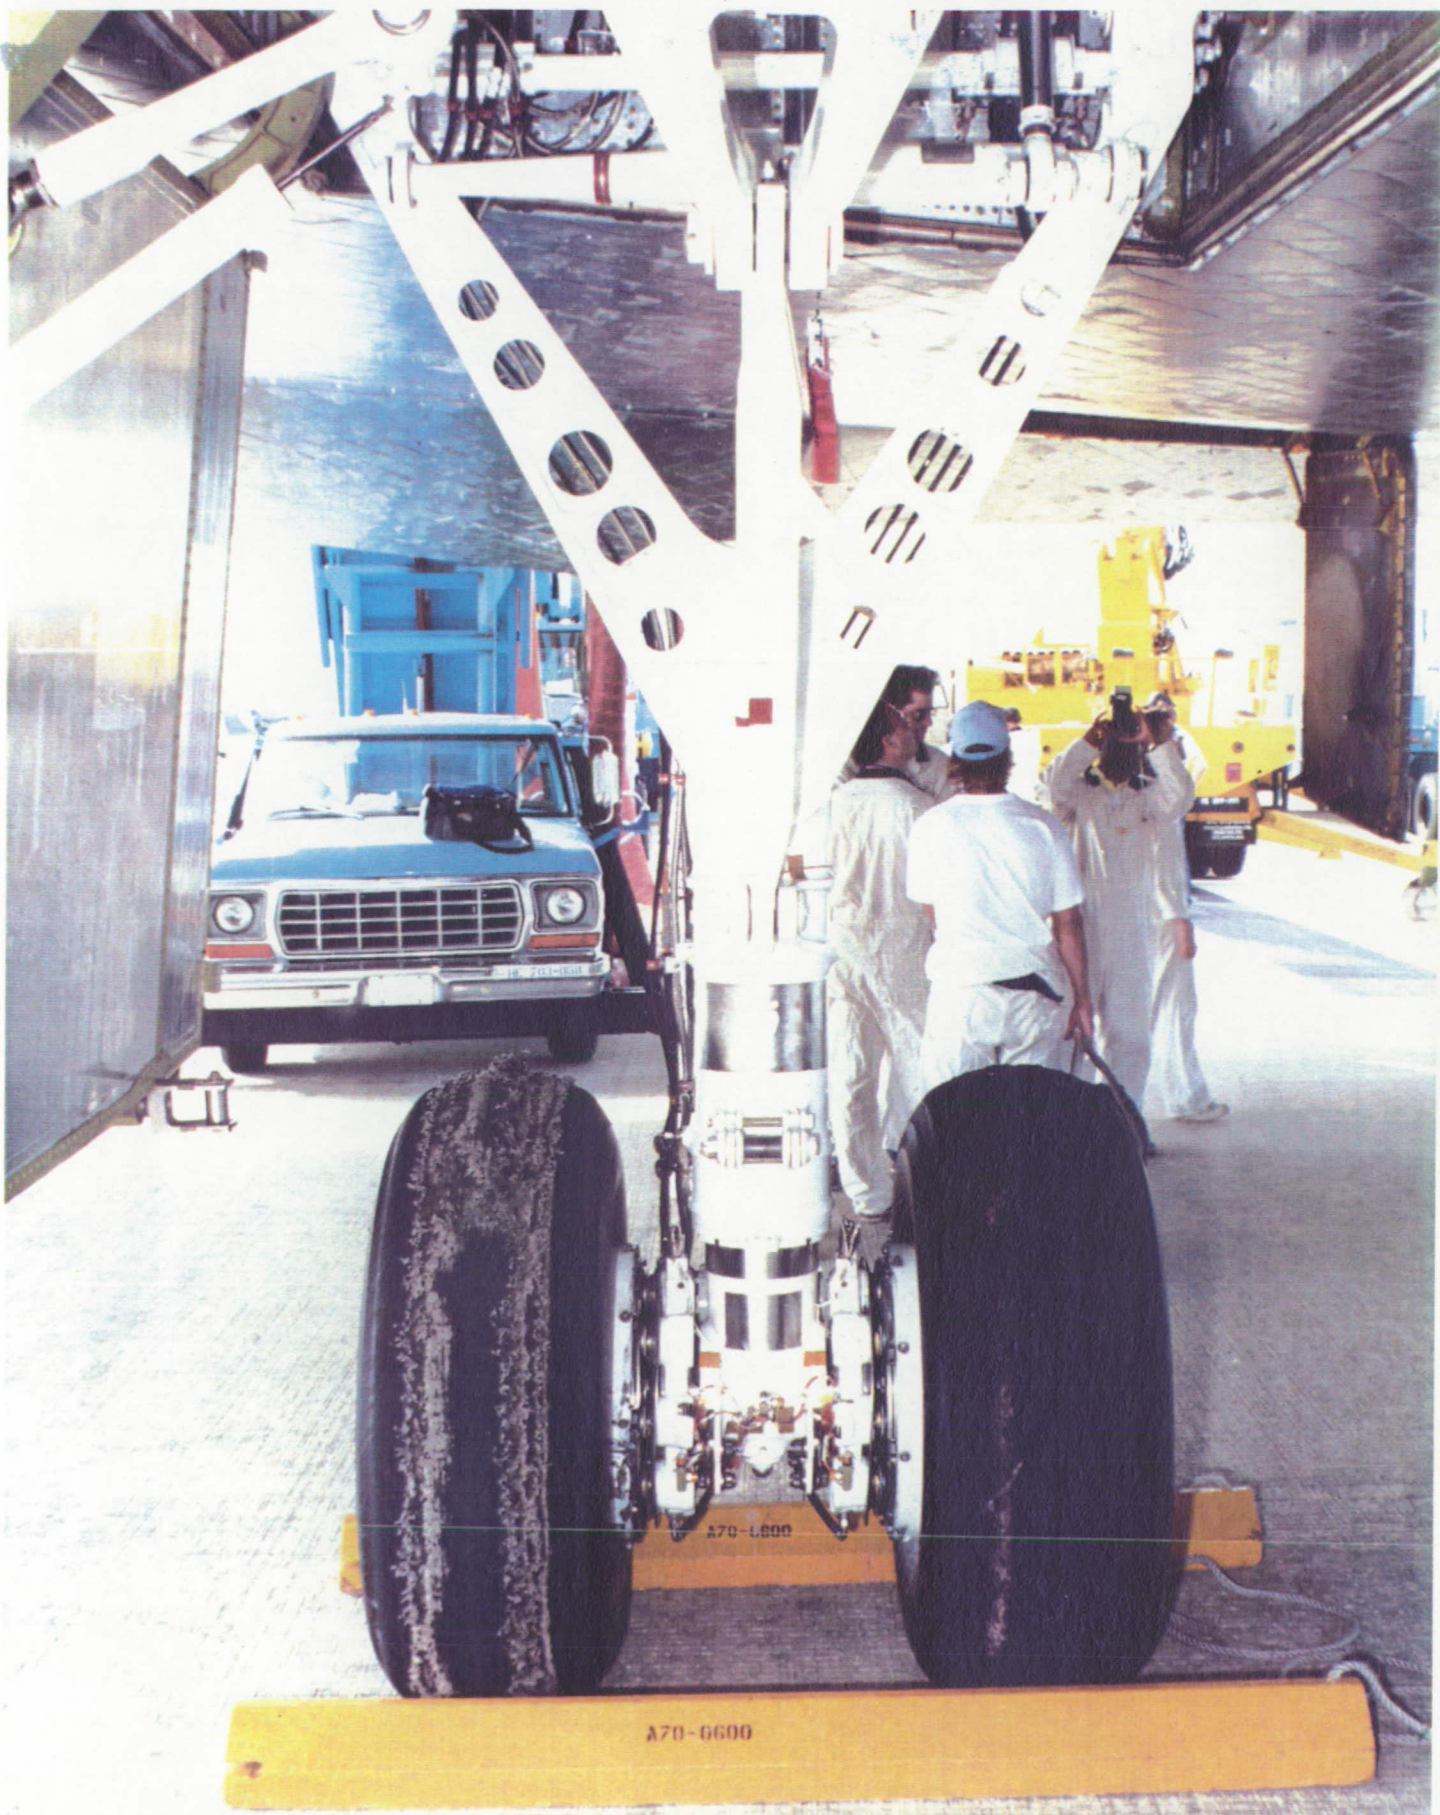
No tile damage was attributed to the loss of tire material from
the main landing gear wheels
